National Register of Historic Places
Continuation Sheet

Bates, John M. and Elizabeth, House
No. 4

Clackamas Co., OR

This is a Petition to delist the Bates House, No. 4 located at 4101 SW Southshore Drive, Lake Oswego, Oregon from the National Register of Historic Places. The residence is a single-story house on a daylight basement. It was designed in the 1950s and completed in 1954. The residence was listed on the register due to its architecture and engineering, including, closets, cabinetry, moldings and brass fittings. However, since that listing in 1990, those qualities (and details) have long ceased to exist.

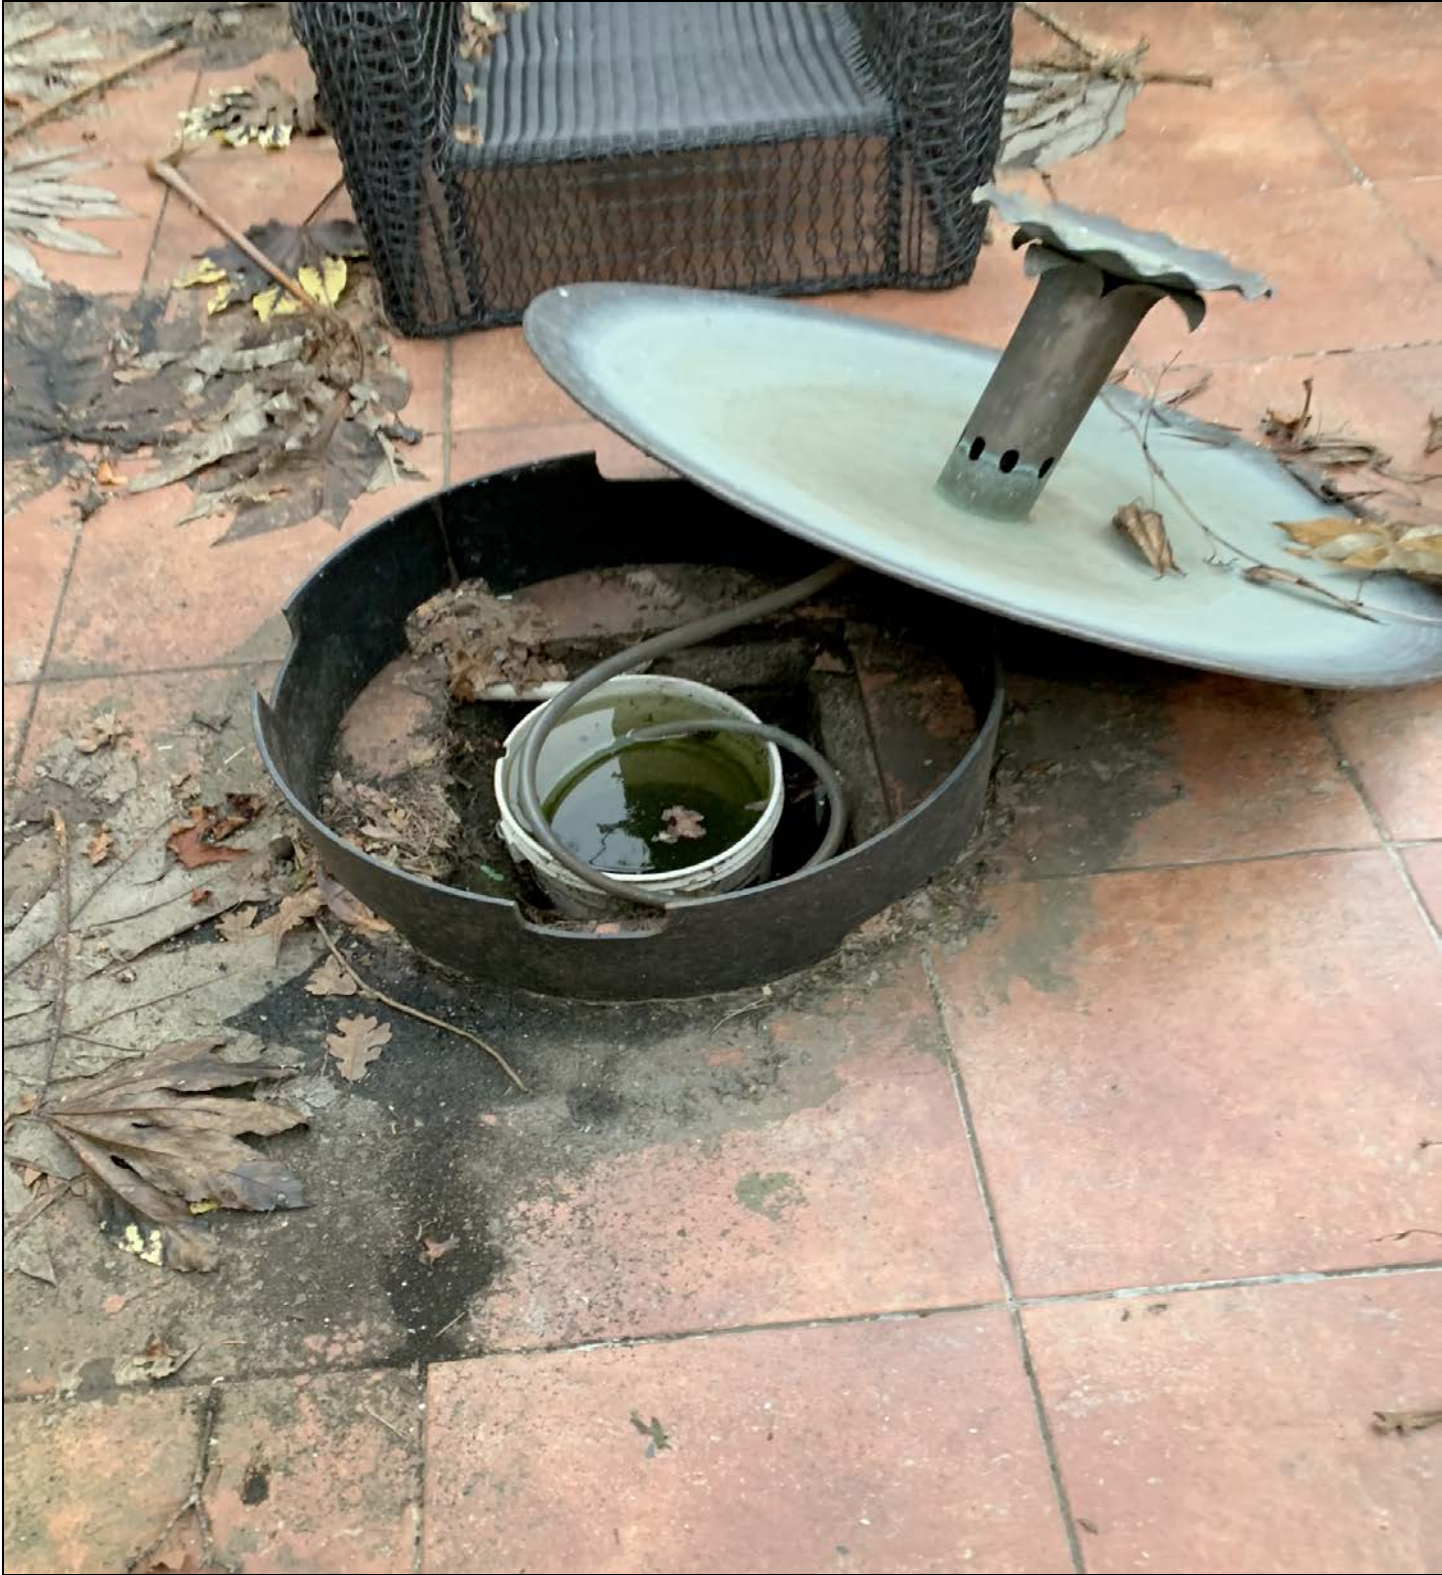
Photo 1 of 15: Broken courtyard feature

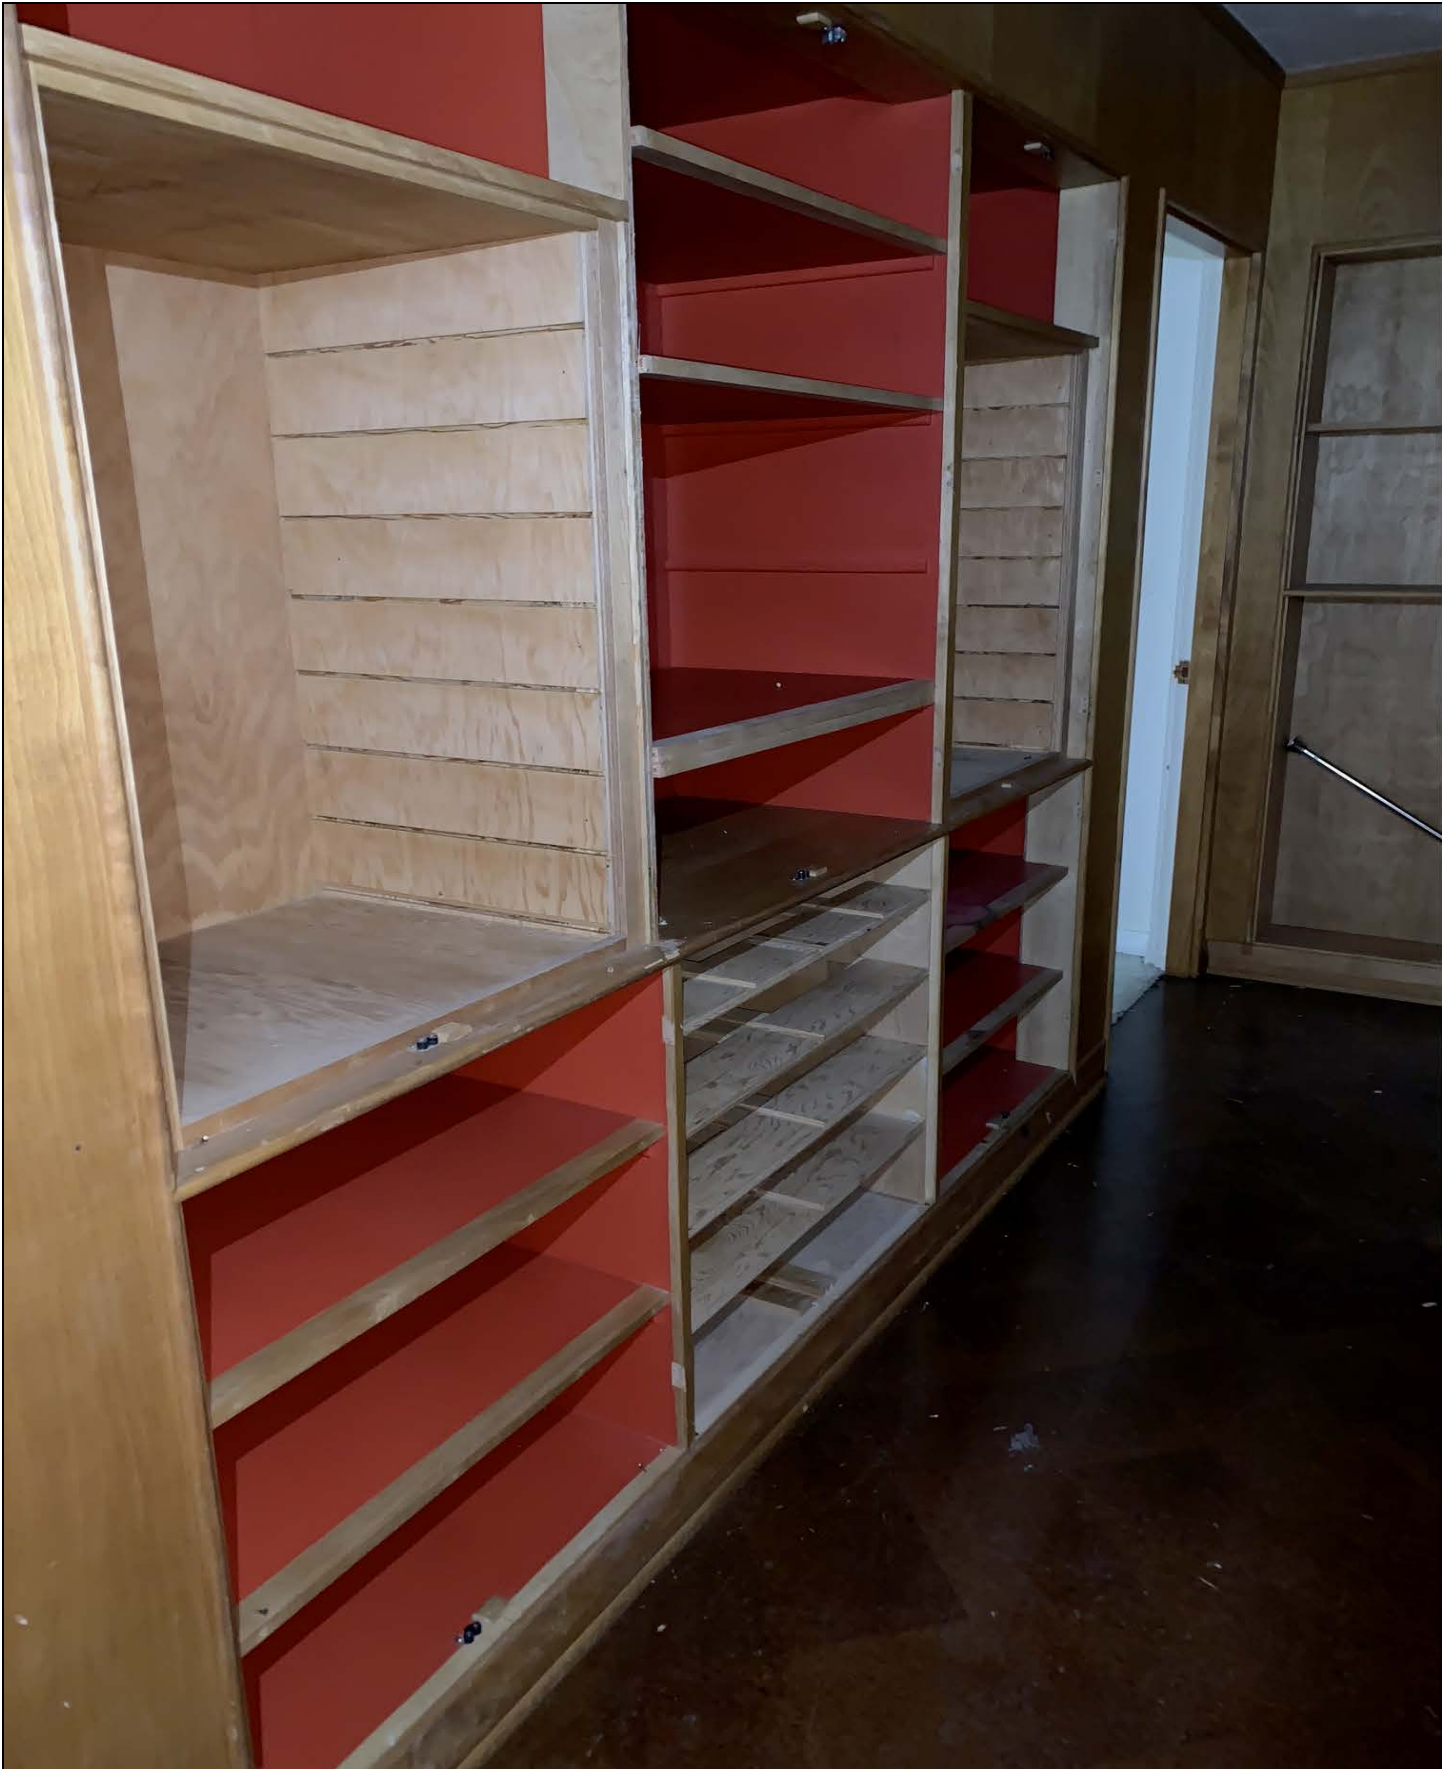
Photo 4 of 15: Stripped fixtures

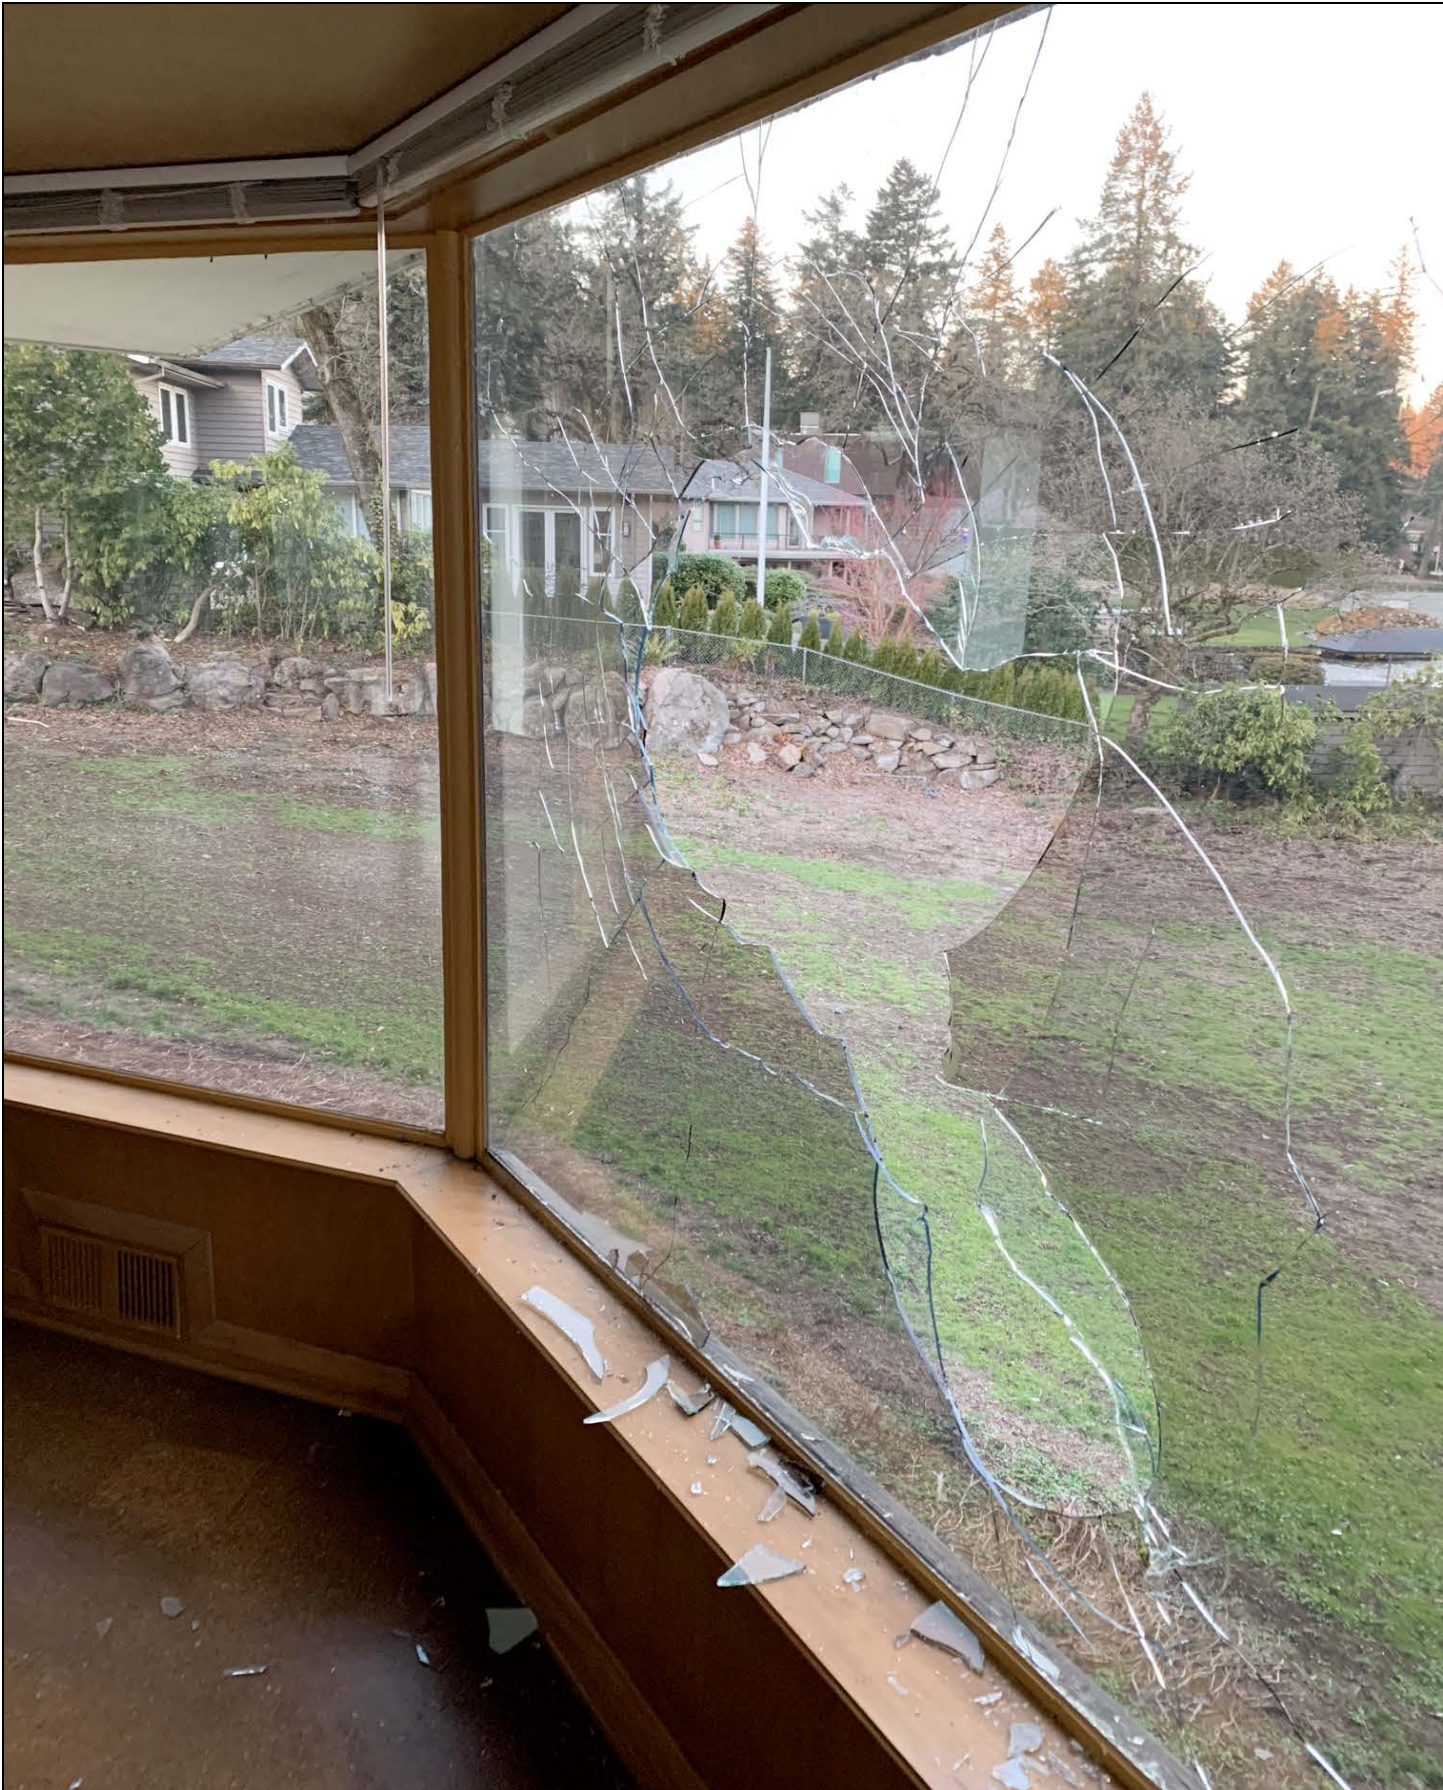
Photo 5 of 15: Broken bay window and lack of landscaping

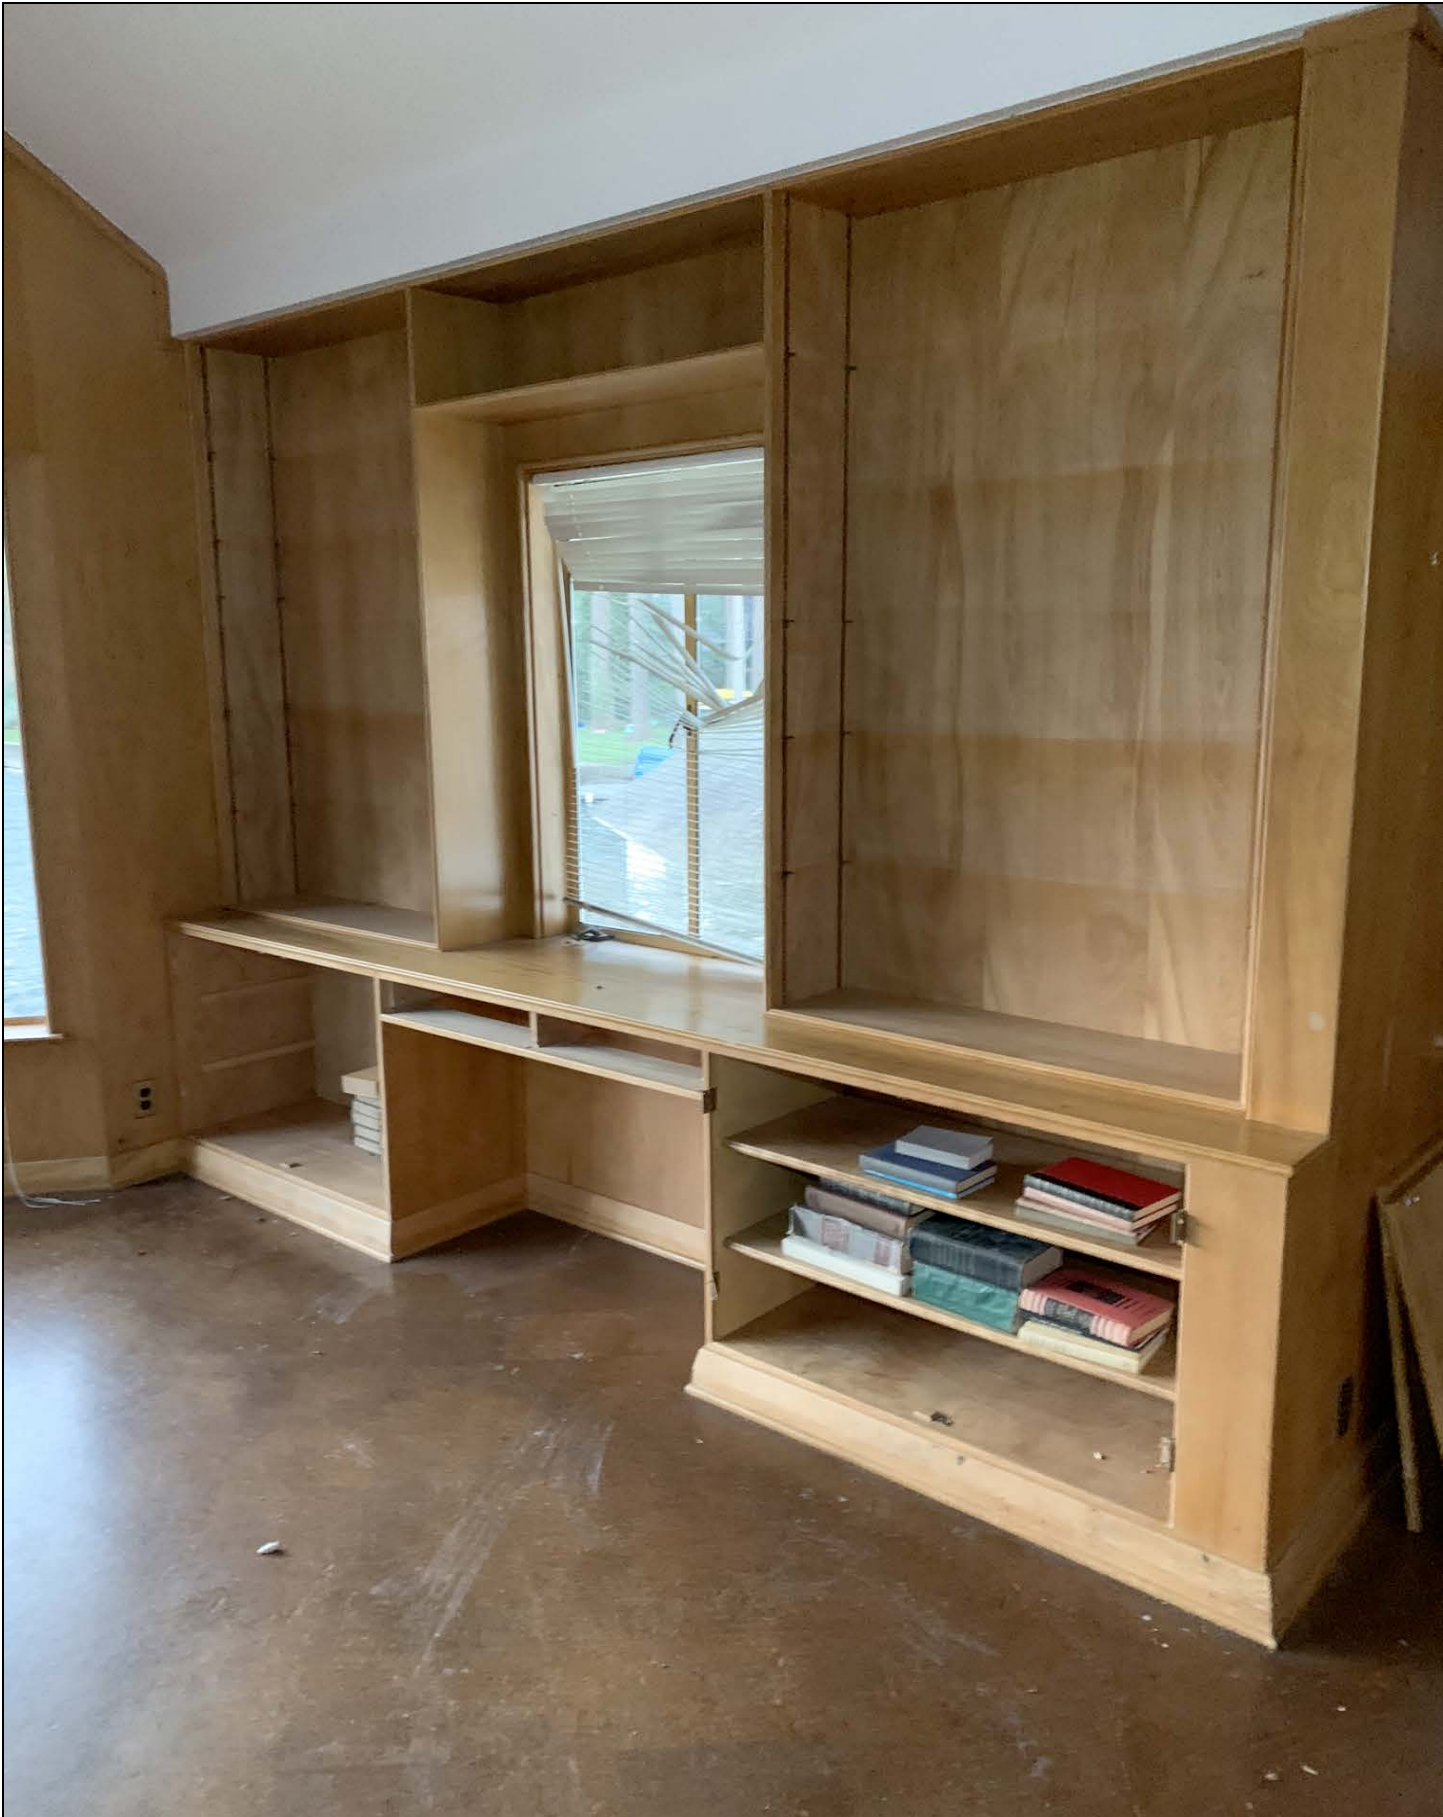
Photo 6 of 15: Stripped built-in furniture; missing deck

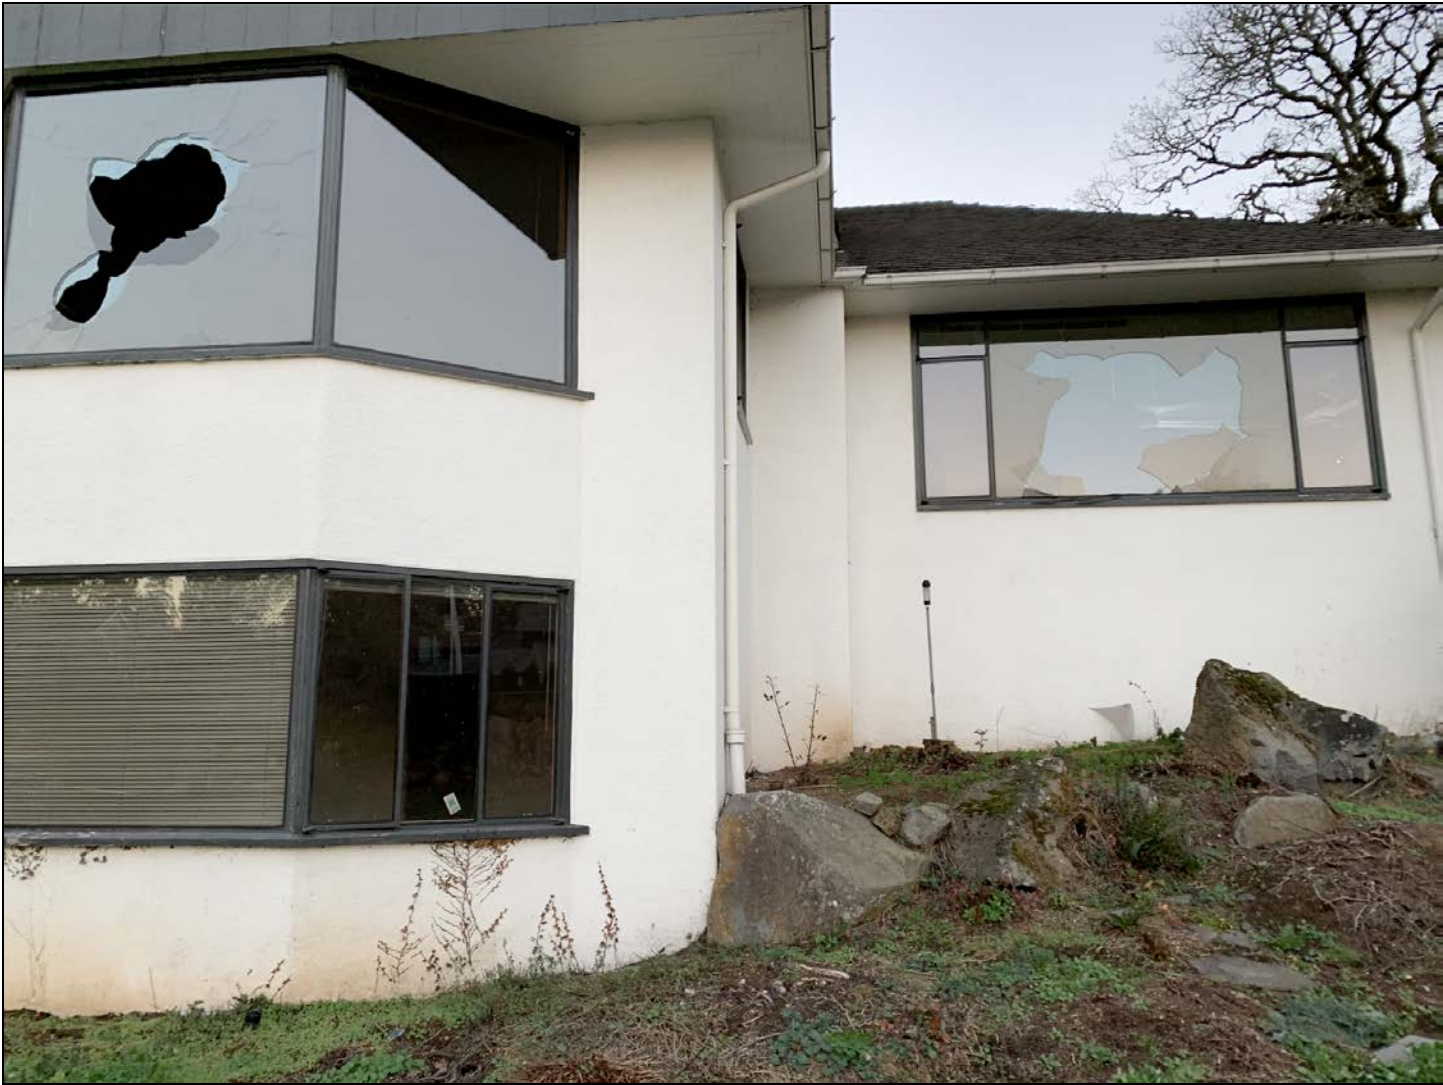
Photo 7 of 15: Exterior, broken windows; landscaping

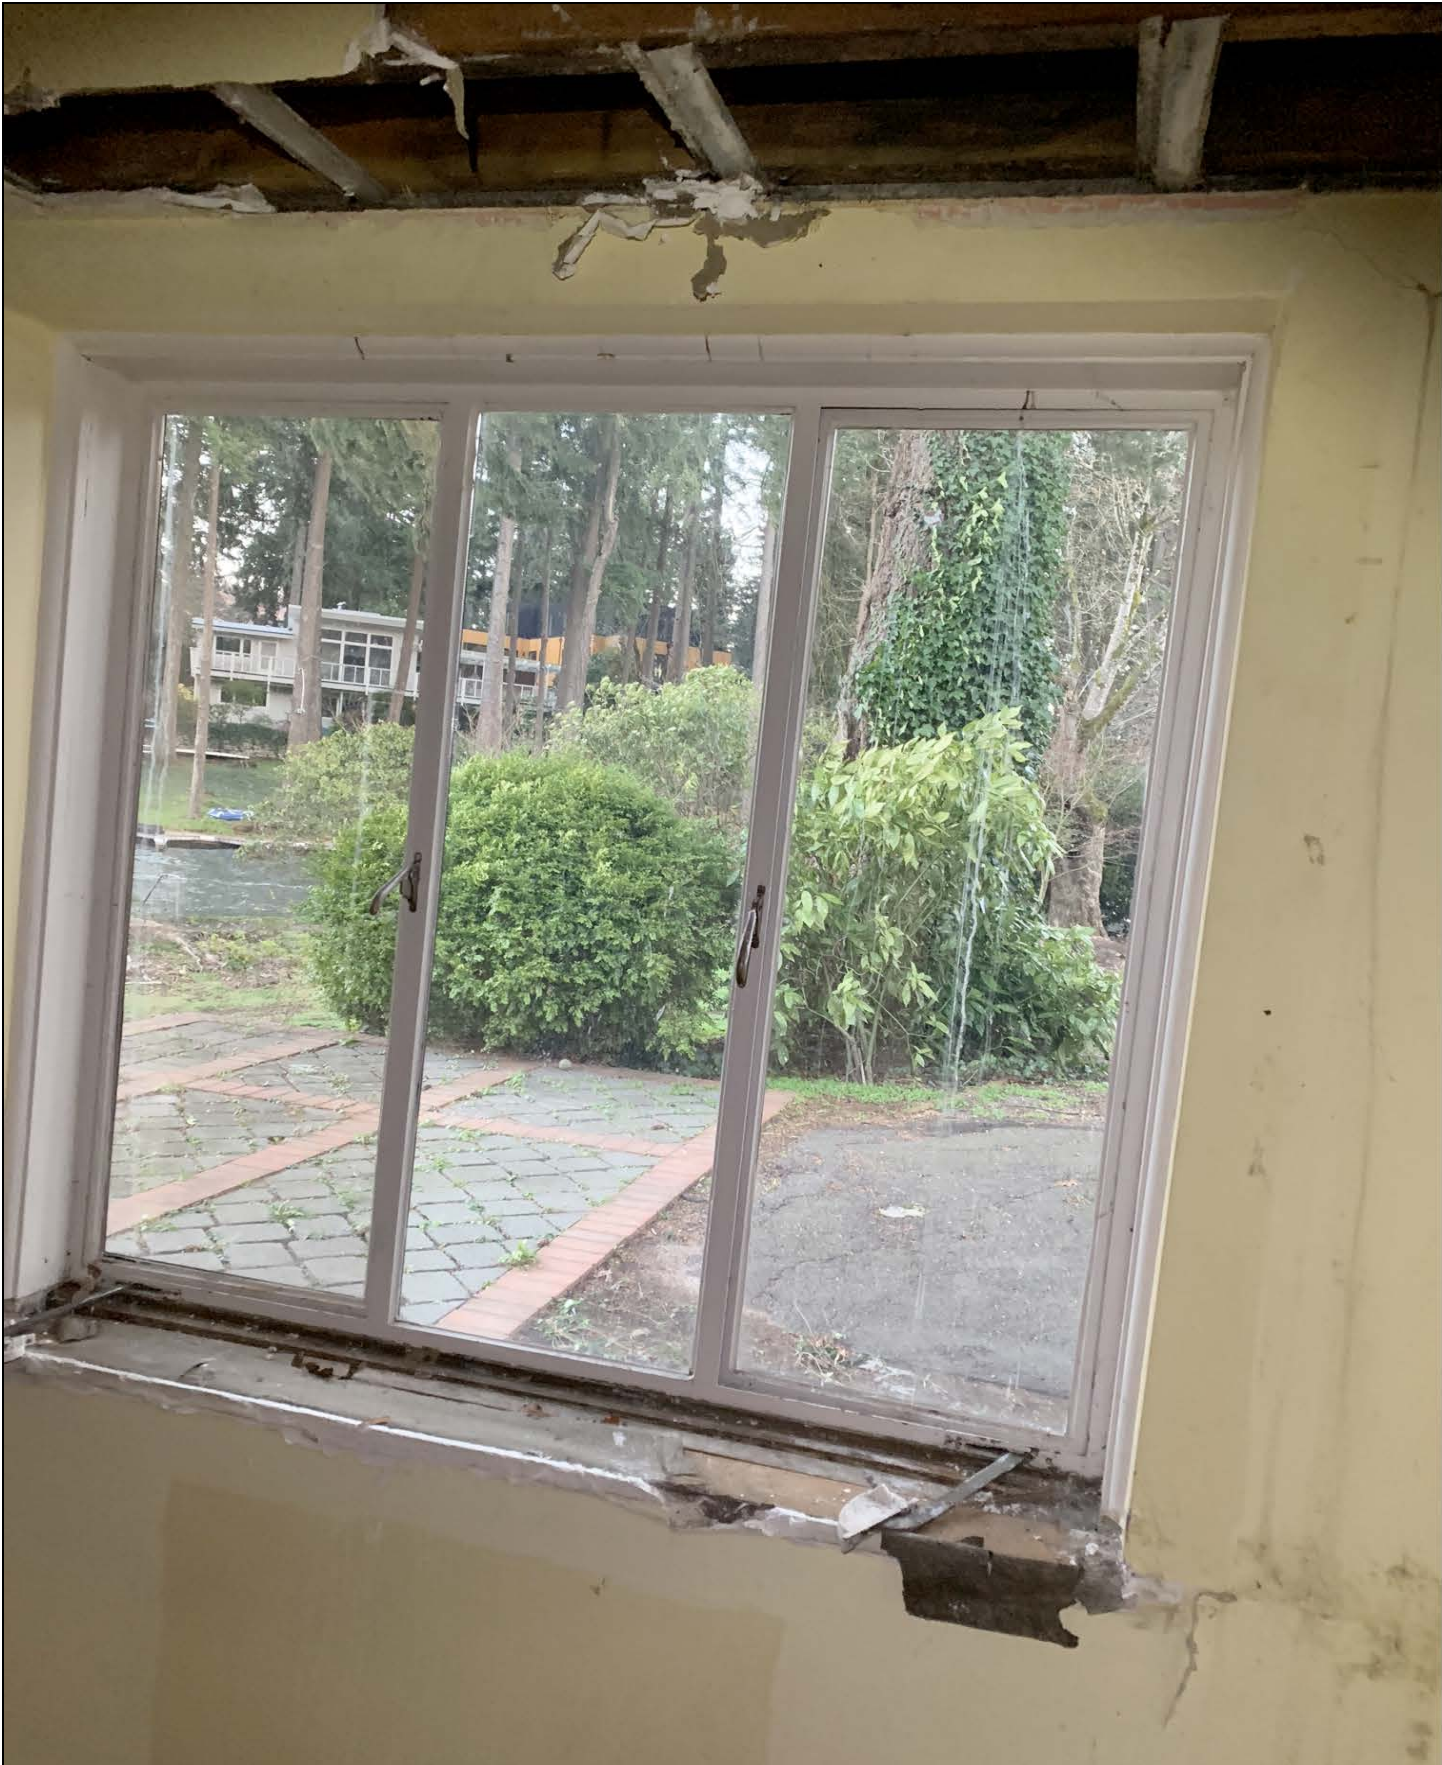
Photo 8 of 15: Failing structure and window

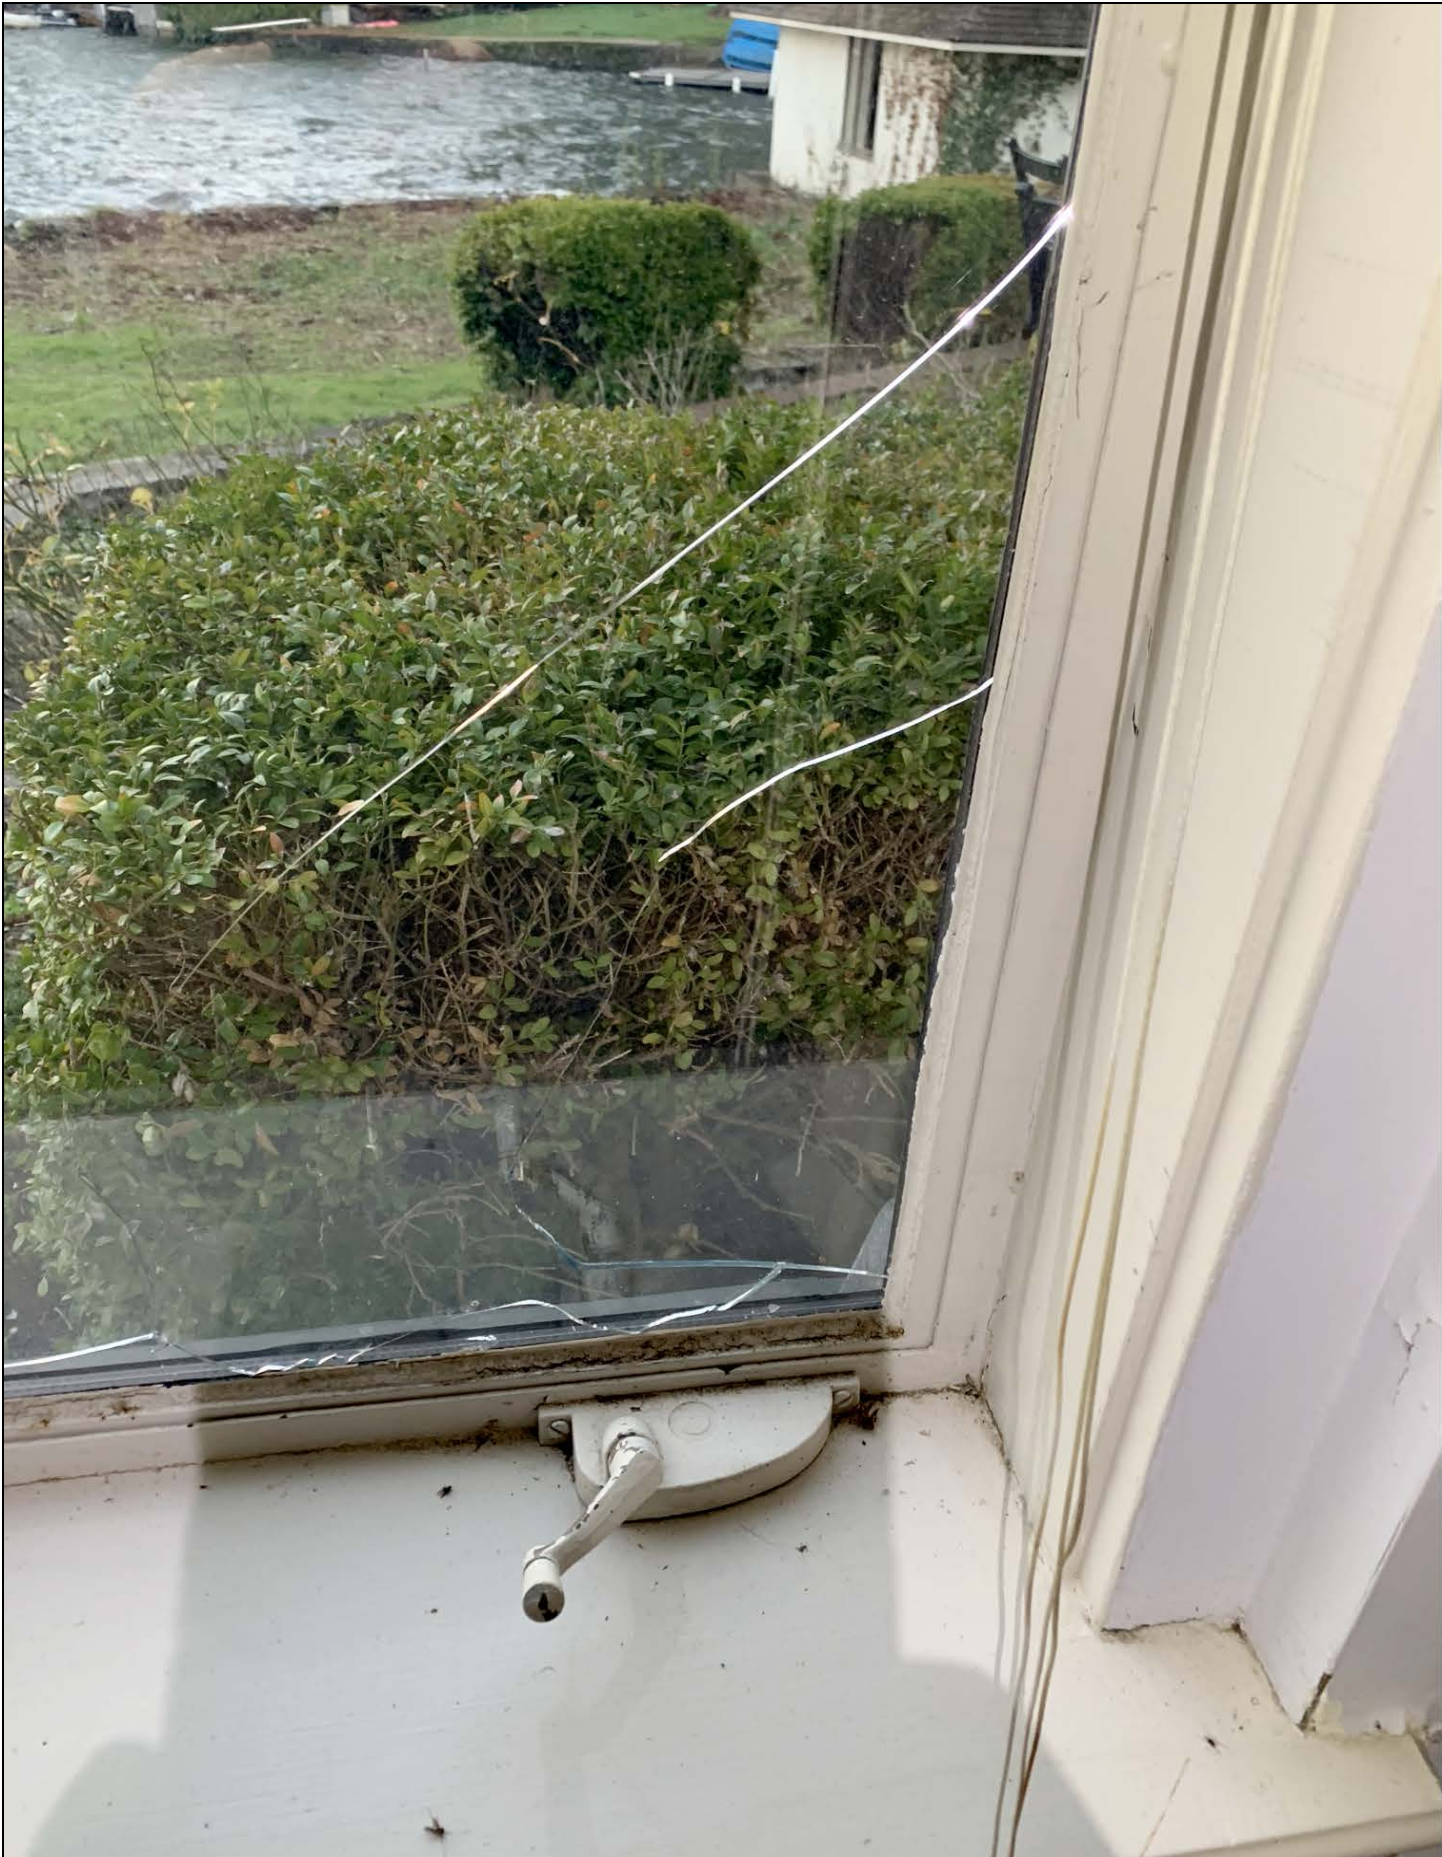
Photo 9 of 15: Collapsing and broken easement window

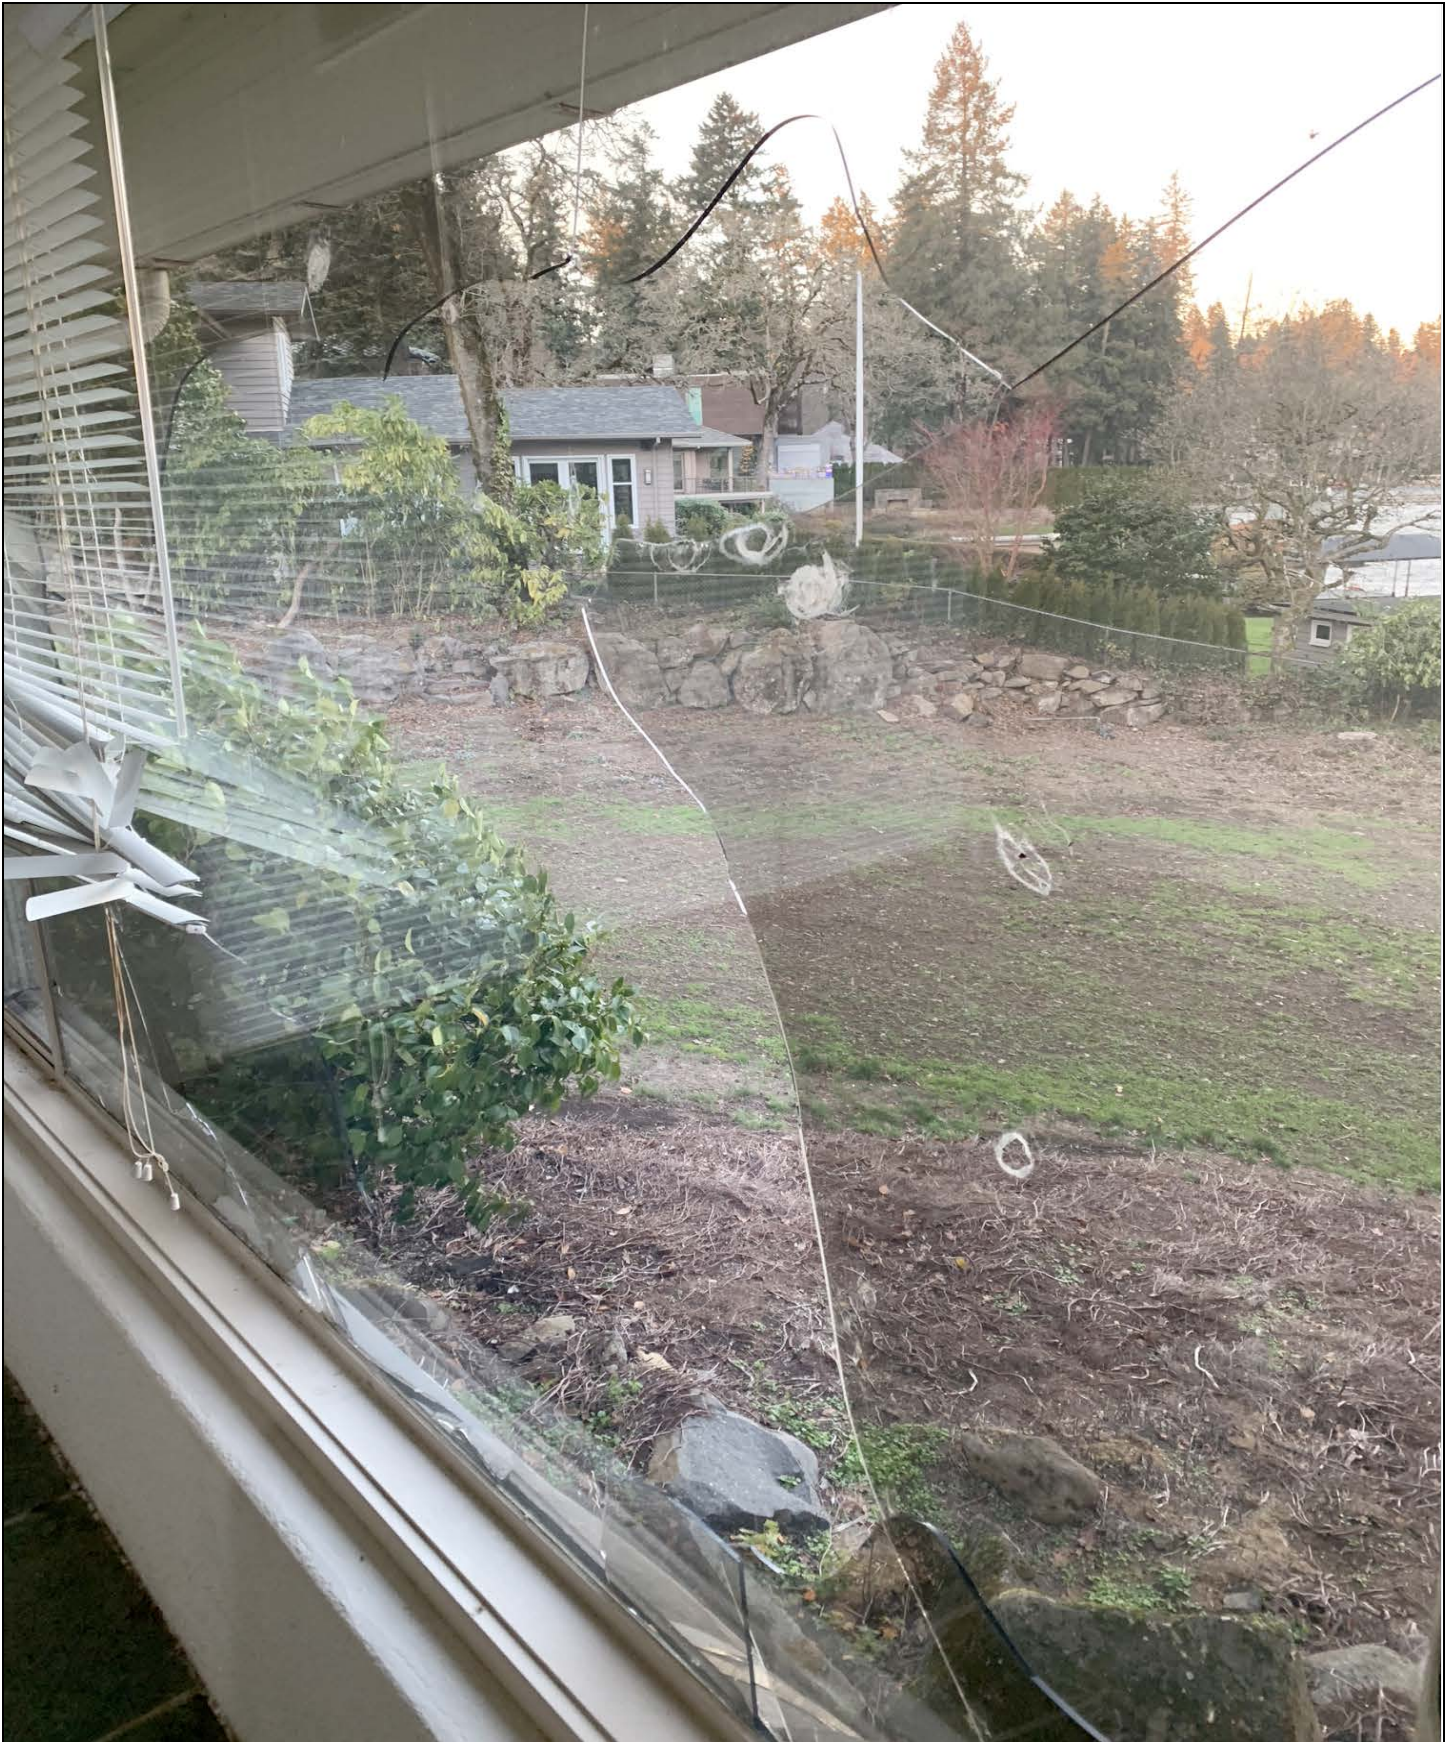
Photo 10 of 15: Broken bay window and landscaping

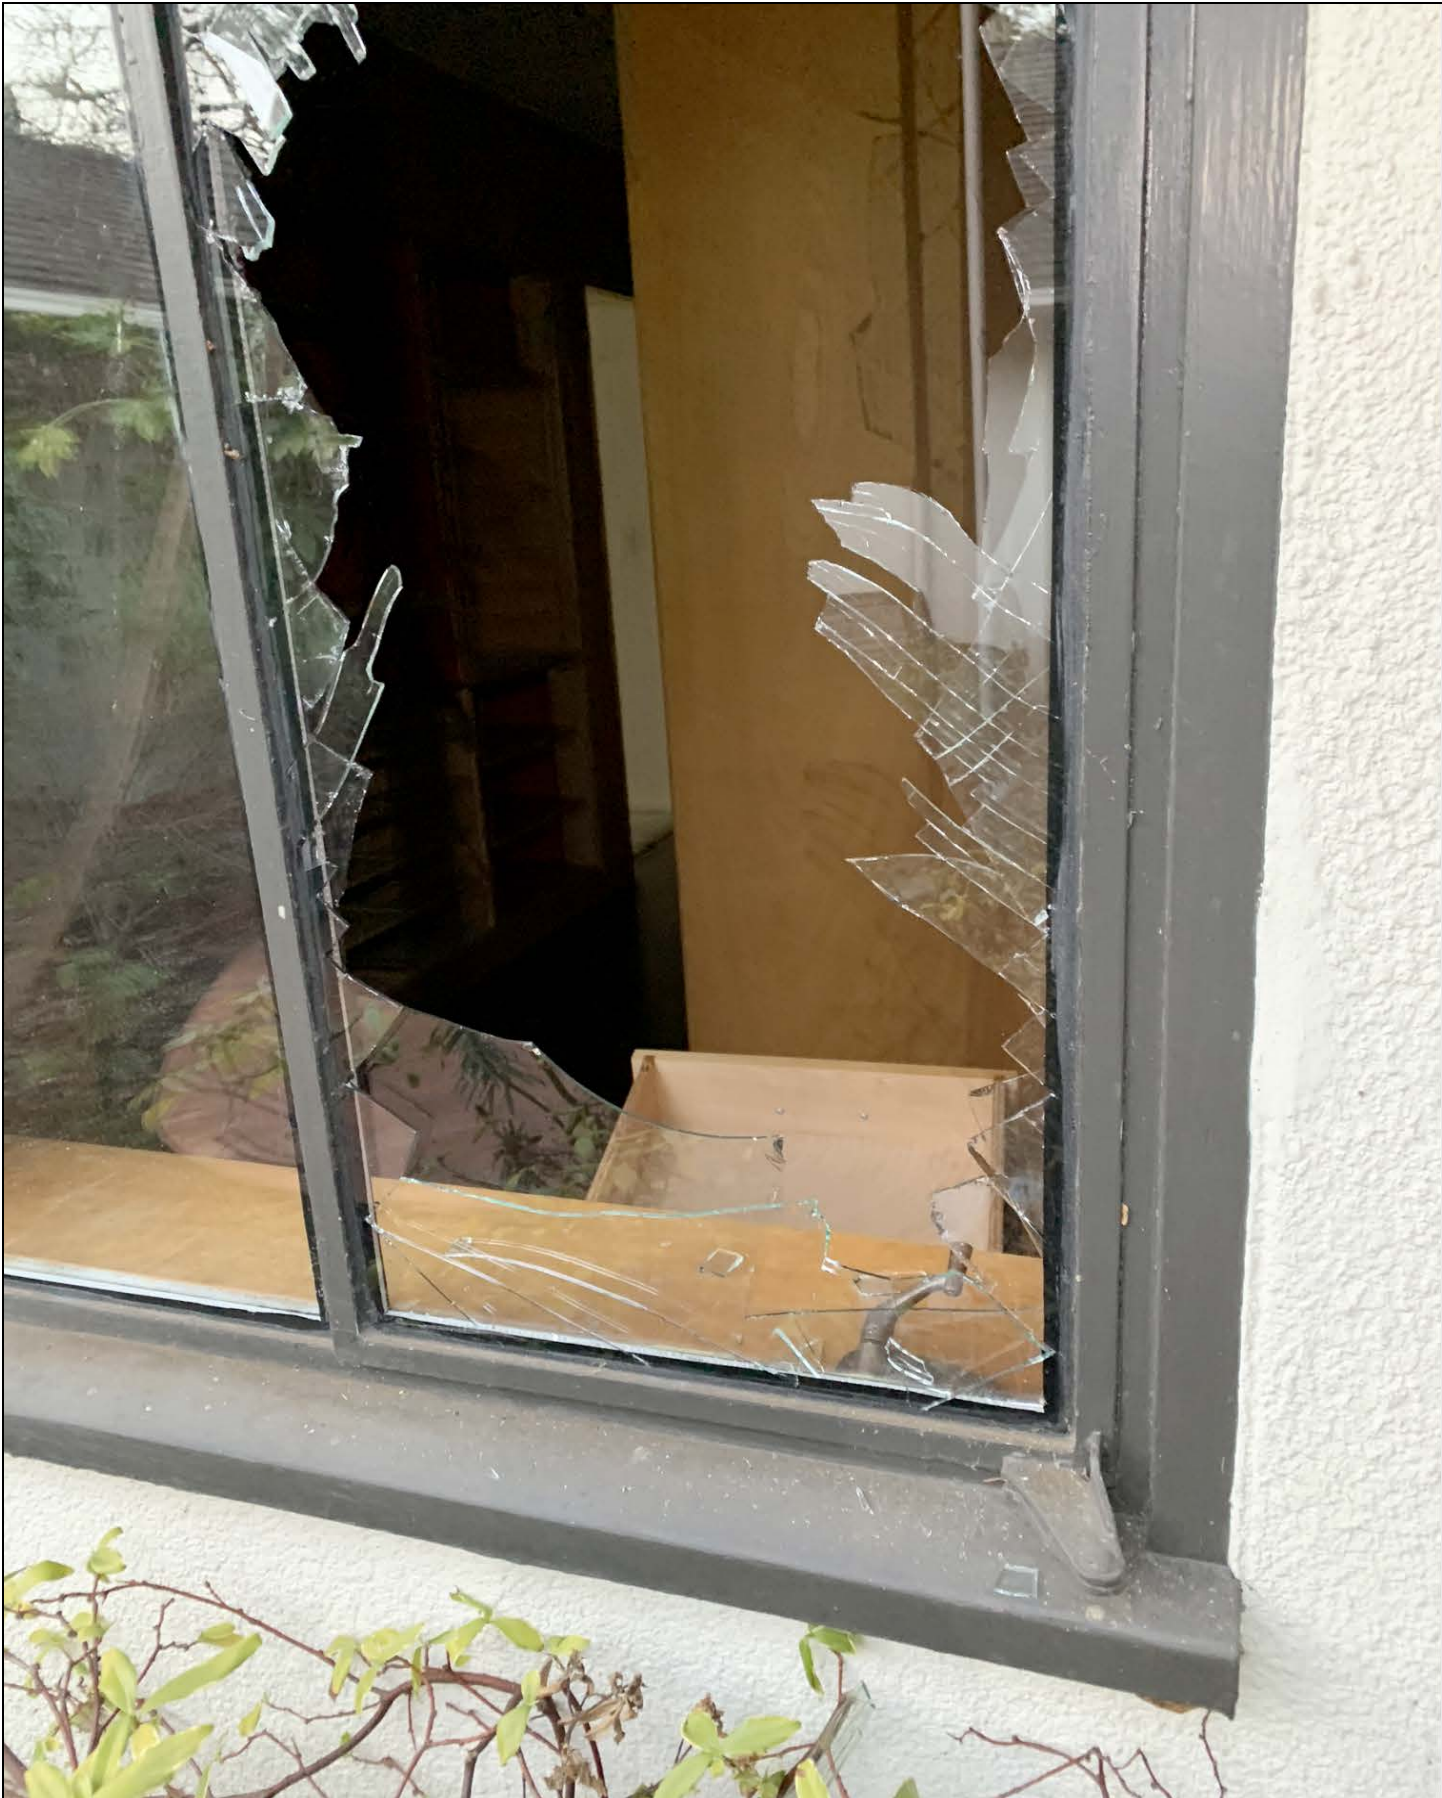
Photo 11 of 15: Collapsing and broken easement window
